SPECIAL AIRWORTHINESS INFORMATION BULLETIN

CE-03-16
January 6, 2003

This Special Airworthiness Information Bulletin (SAIB) provides safety information to **Schempp-Hirth Model Nimbus-3/24.5**, all serial numbers, sailplane owners on the following:

No. 286-34

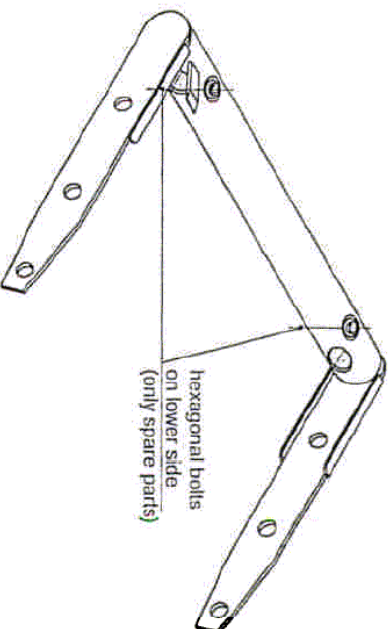
ELEVATOR ACTUATING BRACKET

Play in the tailplane attachment bracket

If an excessive vertical play is found at the tips of the horizontal stabilizer, then the adjustable bushings of the elevator actuating bracket should be tightened such (using a 4 mm Allen Key) that the tailplane will just slide onto its locating pins.
